## Why you do a daily, visual walk around – with a checklist...

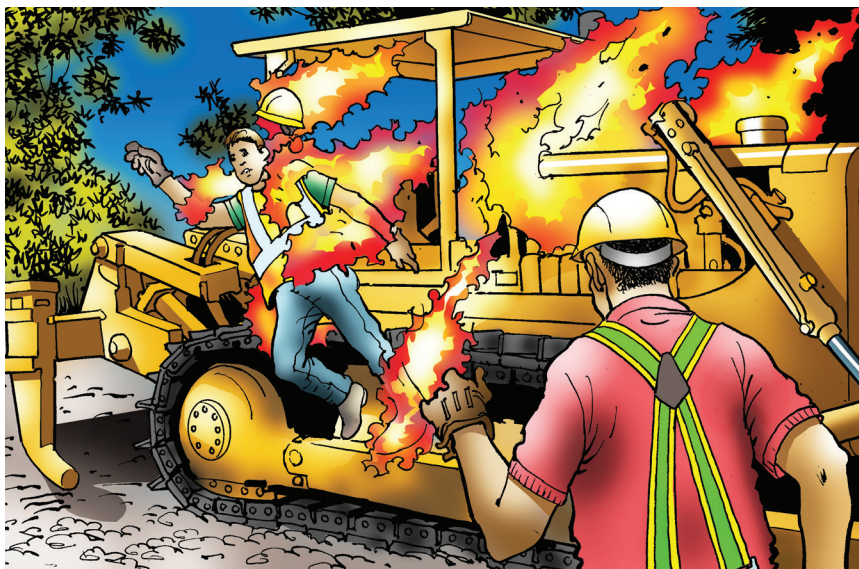
Illustration by Don Lomax

After lunch, the dozer operator resumed work, but unable to loosen any shale from an embankment, he put the dozer into reverse. After backing up approximately 6 feet, a hydraulic line on the left side of the dozer burst, spraying hot hydraulic fluid across the exhaust manifold.

Moments later, flames engulfed the operator. The hydraulic fluid continued to spray from the leaking hose. The owner described it as looking like a blow torch -- with fire shooting out of the engine and back toward the open (ROPS-style) cab.

Tennessee OSHA (TOSHA) identified the source of the fire as a ruptured hydraulic hose in an assembly that powered the dozer's lift cylinder. The assembly was

approximately 10 inches from the engine compartment.

Six years earlier, the manufacturer of this dozer sent owners a service letter indicating that the design of the hose routing on this model could result in excessive abrasion and recommended a modification. However, the owner of the dozer did not act on the information or take corrective action. TOSHA concluded that the hose failed just 2 inches away from the area identified in the service letter.

**1.** This accident might have been prevented had the owner trained his operators on daily walk-around

inspections and used a safety checklist. A thorough inspection takes no more than 10 minutes, yet would have caught a bulge in the hydraulic hose, leaks or excessive abrasion. Defective components or equipment should have been removed from service until the necessary repairs were made.

**2.** Recommendations in OEM service letters and technical bulletins should always be followed, and the information therein should be passed on to operators and field supervisors.
