Tandem lift tragedy

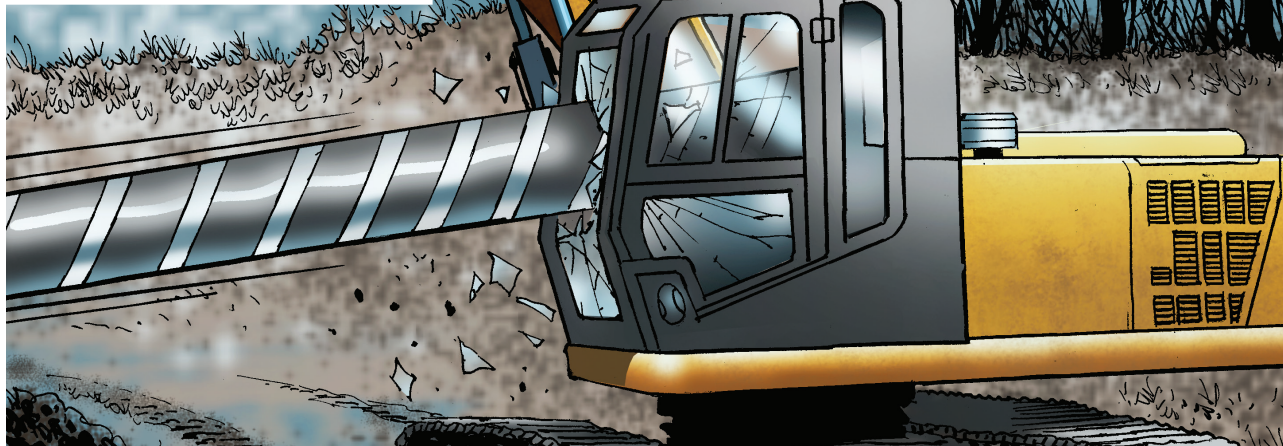
The victim in the second excavator at the opposite end of the pipe attempted to do the same but did not lower his end of the pipe to the ground or detach the sling. At the point where he was halfway around the pipe, the end of the pipe came crashing through the windshield of the cab and struck him in the chest.

Investigators believe the boom on the victim's excavator may have accidentally pulled back, sending the pipe crashing into the cab. The difference in elevation between the two machines may have also caused or contributed to the pipe's movement.

- Implement a comprehensive safe work procedure for tandem lift operations. A lift plan should have been calculated and communicated, so the load could not swing directly in front of the operator's cab.
- Conduct a job hazard analysis on each worksite and procedure before work starts. Provide worker training that includes hazard recognition and avoidance of unsafe conditions. A formal, written lift plan is advisable.
- Implement an effective method of communication between excavator operators and ground workers. This should include hand signals and two-way radios.
- While excavators with chains, slings and other rigging are not considered cranes and governed by OSHA crane standards (OSHA 1970), a review of these procedures can help mitigate risks in complex tasks such as tandem lifts.
