# Quick disconnect

## Stay clear of an excavator's attachments and swing area

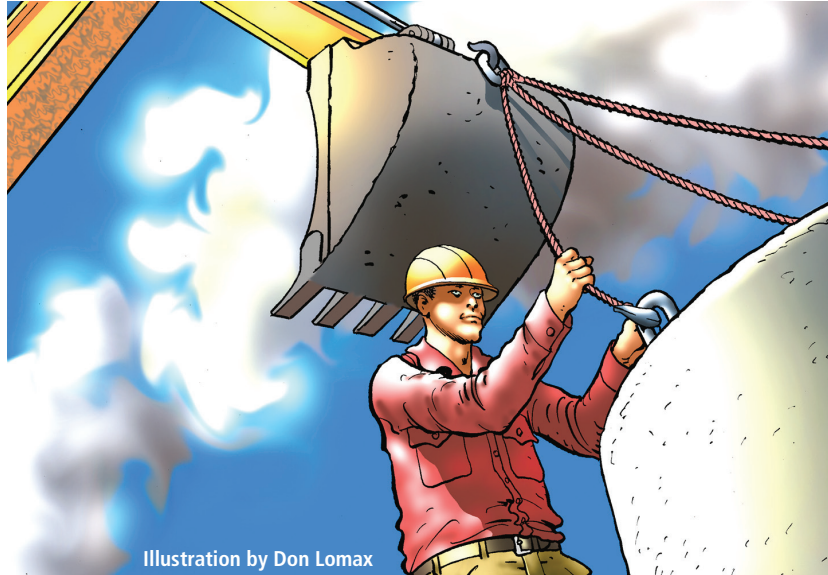
**The accident:** A utility contractor was using an excavator with a lifting eye connected to the bucket to load concrete manhole sections. A co-worker on the ground connected the sections to the excavator and then disconnected them once the sections were placed on a truck. While the worker was attaching a three-leg bridle to the manhole section for lifting, the bucket disconnected from the excavator and struck the victim, knocking him to the ground. He died at the scene from injuries resulting from blunt head trauma.

**The bottom line:** The excavator was equipped with a quick-connect coupler device that operated electro-hydraulically via controls in the cab, with a warning buzzer and indicator light behind the operator's seat. The system is designed to retract the bucket cylinder slowly while the attachment is close to the ground. A post-accident investigation showed a malfunction in the hydraulic circuit that enabled retraction of the quick-connect system's slide lock in any bucket position. Also, contributing factors were found including intermittent electric power to the switch, which prevented the indicator light and buzzer from activating immediately; as well as the operating switch and indicator light being located outside of the operator's view. The operator said when the buzzer went off, he thought it was a temperature or oil pressure indicator.

Always conduct both a visual and operational check of your machine. Even if you see nothing wrong visually, all excavator functions – including cycling the coupler mechanism and curing the bucket – should be completed prior to operation.

If you're on foot on a site, stay away from machine swing areas and remain clear of attachments when lifting. In this instance, if the victim had used the proper length of wire rope for the bridle legs, the bucket could have remained on the ground while the legs were rigged to the lifting eyes of the manhole sections, eliminating the risk of being struck by a falling bucket.

The quick-connect coupler system was added to the excavator involved in this accident. Although the manufacturer recommended the operating switch box be installed in the cab where it would provide maximum visibility, the switch was installed behind the operator to prevent accidental activation. A more visible location would have alerted the operator there was a problem earlier. If you're in the excavator cab, locate the warning light prior to operation and familiarize yourself with the sound of the warning buzzer so you won't mistake it for another type of indicator.
