# Demo dangers

## Knowledge is the key to staying safe during demolition

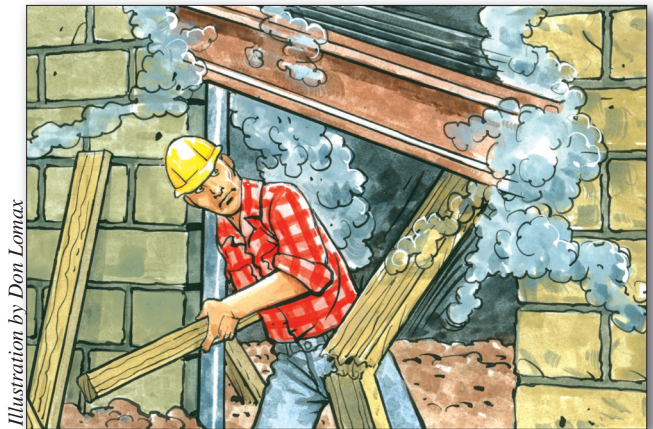
**Accident:** An ironworker for a steel erection company was performing demolition work on a hollow block wall inside a building. An opening had been cut in the wall for a doorway, leaving 16 inches on either side, and leaving the header beam suspended without support. After noting that a nearby train track was producing building vibration, the company attempted to stabilize the header with epoxy and lumber supports. Prior to installation of the channel posts, the worker began to remove the lumber to minimize the risk of fire when welding the posts. The entire channel iron header assembly broke loose, falling on his head and shoulders. Because the assembly weighed approximately 4,000 pounds, a jack was necessary to remove the beam from the victim. He died several days later from blunt force head trauma.

**The bottom line:** An investigation determined the contractor did not consult with the engineer who designed the structural support system, and therefore was unaware the changes made were not compatible with the demolition plan. The investigation also determined the boards were of an unusual size, unmarked and securely fastened, so the victim could have concluded the lumber was an architectural detail that could safely be removed.
