Deadly drops

Collapses aren't the only source of danger when performing demolition

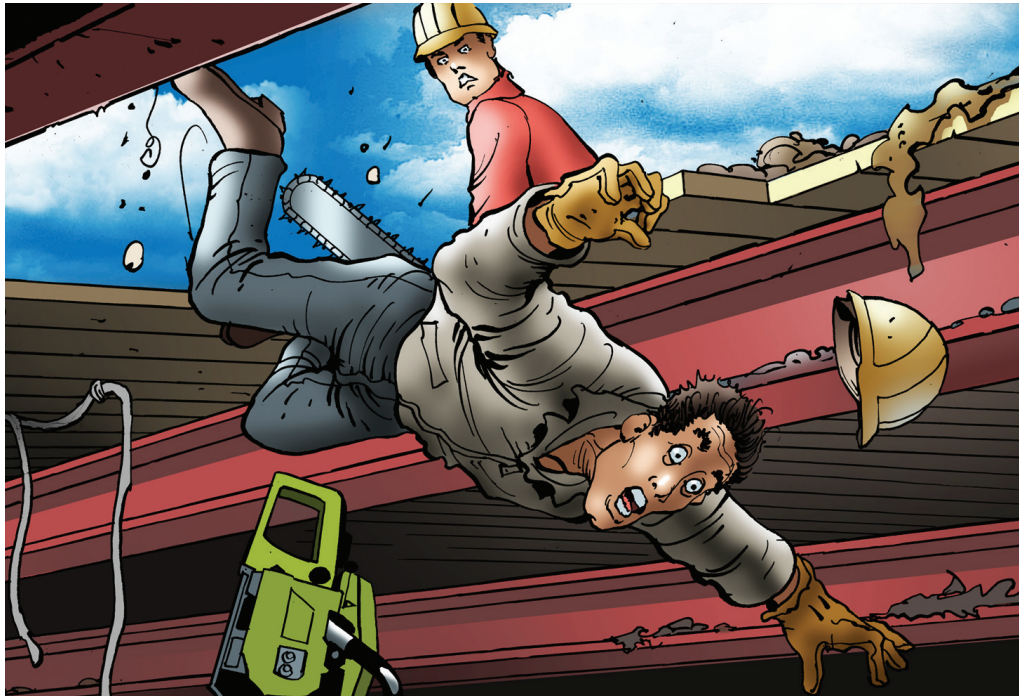
The accident: A construction crew on a large renovation was working on a rooftop demolition project. The five-man crew was manually removing tar, gravel and wooden planking from the roof to expose the steel gridwork beneath, making chainsaw cuts to the planking to ease removal. One of the workers moved too close to an opening, and fell 26 feet to a waste heap below. The worker went into cardiac arrest and was later pronounced dead at a hospital from a ruptured aorta.

The bottom line: A post-accident investigation determined that, as the morning progressed, the crew removed more and more of the planking, exposing themselves to increased danger. The chainsaw cuts to the planking made just prior to the accident were in close proximity to the 10- by 10-foot opening where the worker fell.

Adapting to the site: OSHA standards would normally require floor openings be guarded by a either a standard railing and toeboards, or a cover capable of supporting the maximum intended load. However, in a situation when you're removing the entire roof, neither railings nor covers would work or make sense. In this situation, personal protective equipment in the form of lifelines and harnesses should have been provided to the crew. **EW**
